Locating Stuck Pipeline Pig Using High Energy X-Rays and Digital Radiography Detector

Oceaneering helps operator solve major flow disruption issue

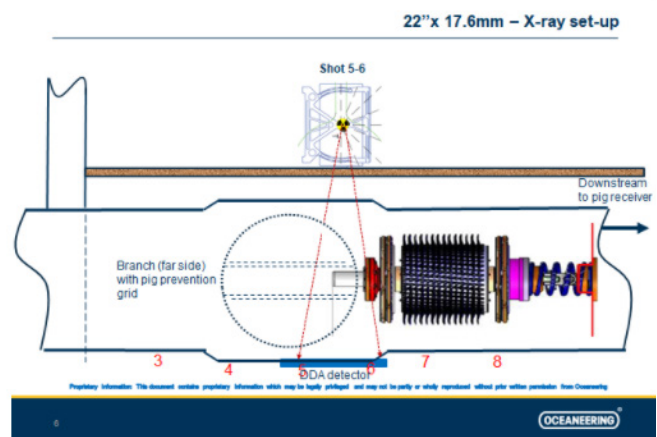
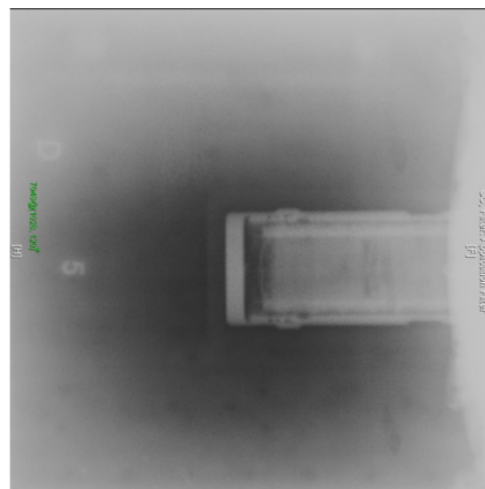
By using this innovative solution, the customer was able to resume pipeline production operations after only three months. We were able to positively confirm the pig position and the absence of pig debris in the tee prevention bars and inside the NRV. The pig's location would have prevented valve closure or even caused damage to the valve internals during the closure which would have required a major pipeline intervention and workover to replace the valve. Around 20 m of pipeline was radiographed before eventually finding the pig. One of the main X-ray set-ups and actual X-ray digital image through the process thick wax product is shown.
