Oceaneering Completes Water Injection Pipeline Repair at Field Offshore Angola

Successful repair enables customer to resume operations and enhance production

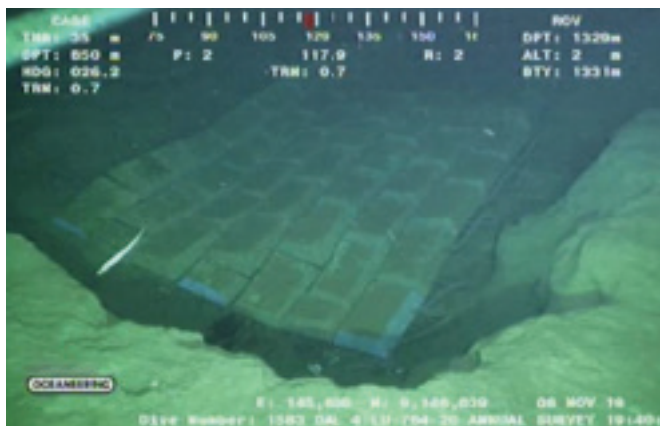
The seabed conditions in both repair locations was similar and was composed of very soft, highly-plastic clay. The water content was near 120 percent with a plasticity index of 100 to 130 percent. These conditions dictated the requirement for significant site preparations including the use of grout bags and concrete mattress installation.

The objective of Phase 1 was to prepare the seabed around the leak areas. This included excavating, using a grout bag to fill a crater at one of the repair locations, and the installation of concrete mattresses at both locations. The seabed was stabilized to ensure it was able to bear the weight of the clamp installation frame and the ROV's impact while it was working in the vicinity of the pipeline during clamp installation tasks.
