Oceaneering Inspection Solution Combines High-Energy X-Ray and Digital Detector Array to Confirm Fitness for Service on Large-Diameter, Heavy Wall Risers

Solution safely delivers high-resolution images and corrosion measurement data in near real time on an offshore installation

Project Overview

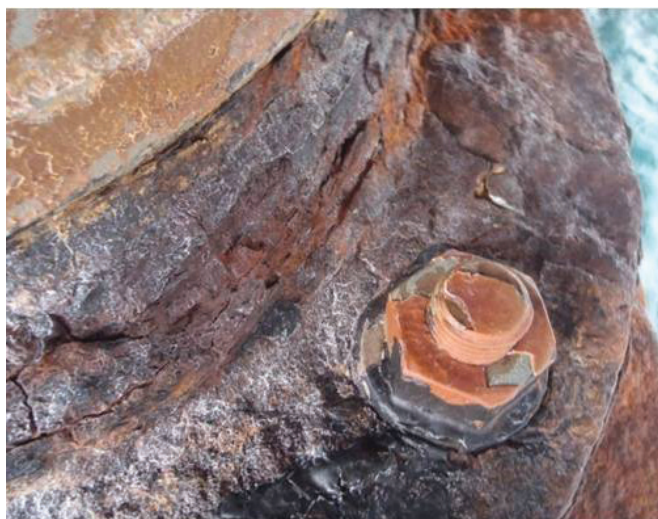
Measuring the remaining wall thickness meant taking X-ray images around the circumference of each pipe tangentially. Although this is a conventional radiography technique, very powerful equipment capable of penetrating the very thick "chord" lengths of the risers was needed to complete multiple-angle exposures to ensure full area coverage. Oceaneering SMEs proposed a 7.5 MeV PXB betatron with digital detector array (DDA) radiography as a possible solution.

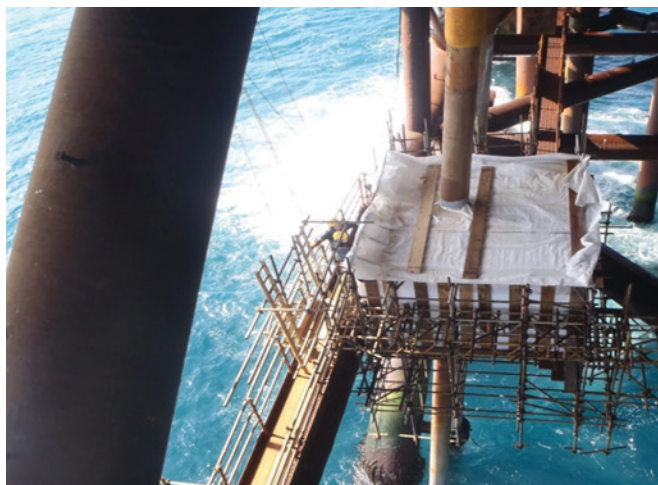
Oceaneering designed and manufactured customized hardware used to support the completion of the precise radiography. A project-specific positioning trolley and radiation beam angle guide interfacing with the pipe flange ensured that each exposure was on target and that a comprehensive, accurate set of data was produced and used to assess the pipe thickness.

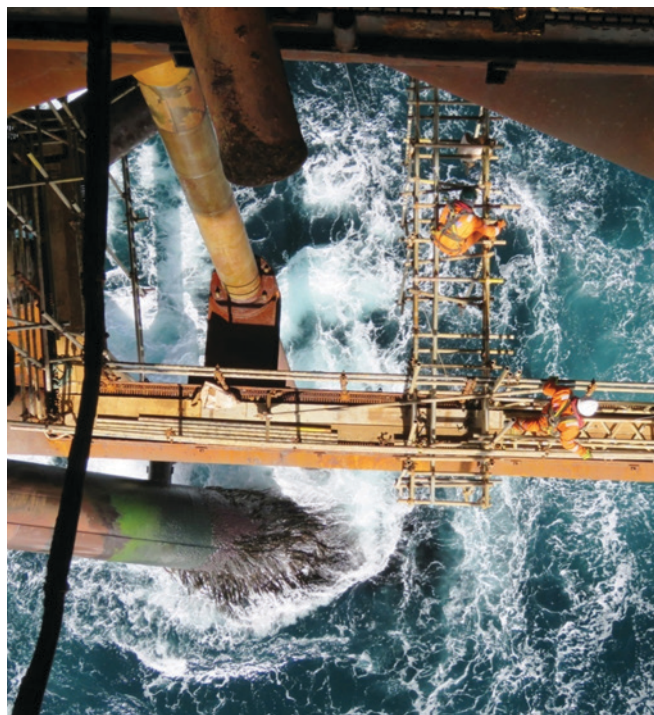
A twin-wire rigging system was used to lift and lower the heavy equipment from the deck level through a floor grating hole down to the scaffolding platform. Manual handling and positioning of the 220-lb (100-kg) accelerator head at the workface was achieved by fabricating a bespoke, wheeled support trolley and by rigging an overhead lifting beam in the radiation habitat.
