Oceaneering Develops Bespoke Integrity Management Strategy for Internally Corroded Pipe Clamps

The strategy allows clients to effectively screen, measure, quantify, and evaluate acceptability of metal loss inside the pipe clamps to facilitate replacement planning

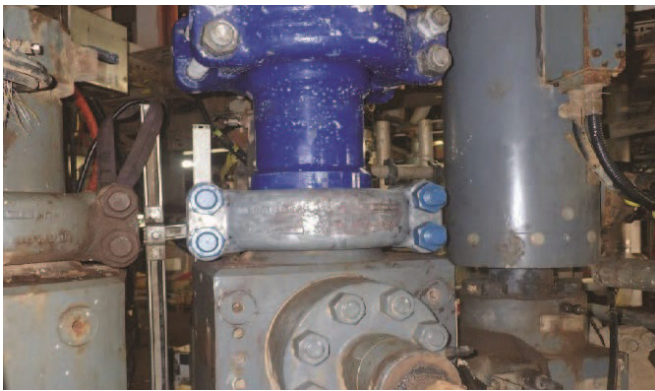
Removal of a clamp connection during routine maintenance on an aging asset revealed significant metal loss on the inner cylindrical surface of the clamp, even though the external clamp surface was in apparent good condition. Visual inspection

of the corroded clamp discovered plugged relief grooves, preventing the free drainage of moisture from the uncoated inner cylindrical clamp surface. Inspection of a sample of similar clamps revealed plugging of relief holes and angled installation inhibiting draining on a large number of clamps in critical high-pressure applications.

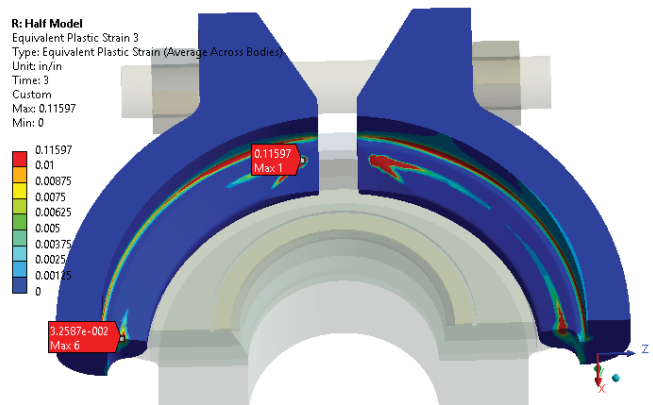
Following code design procedures and two-dimensional, linear-elastic finite element stress analysis, the maximum allowable axial force and bending moments for the clamp configuration at the maximum design pressure, was calculated. The maximum allowable axial force, bending moments and pressure were subsequently applied to a three-dimensional elasto-plastic stress analysis model, while incrementally increasing metal loss, to determine the limits of permissible metal loss, while maintaining associated localized plastic deformation to code acceptable levels.

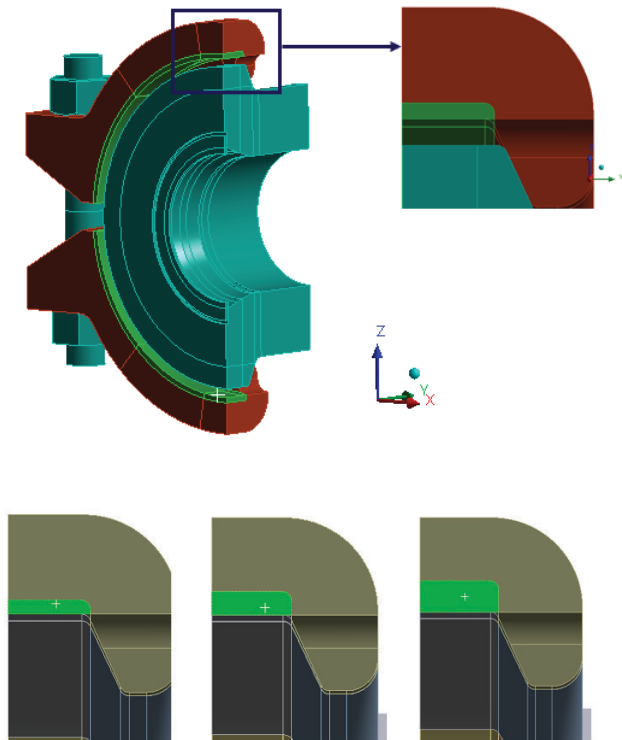
After determining the maximum allowable metal loss for worst-case design condition, sensitivity analysis was performed to determine the tolerance for further metal loss in the event of reduced levels of pipe stress and structural loads. A table of maximum allowable metal loss and corresponding level of maximum allowable structural load, expressed as weight force or “suspended load,” were developed for easy reference and expedient integrity evaluation of clamp condition without the need for additional calculative assessment.

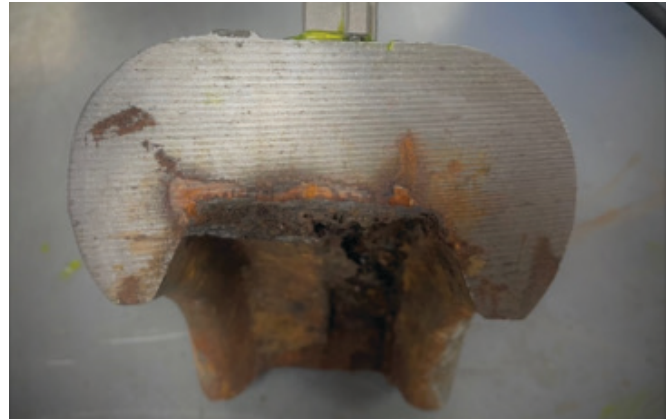
Various ultrasonic thickness measurement techniques were tested on the corroded ex-service clamp to verify the effectiveness of detection and accuracy in quantification of metal loss.

Another challenge would be how to measure metal loss on the inside of the clamp due to difficult clamp configurations. Some clamps had a surface finish with embossed lettering and rounded corners. The team conducted trial ultrasonic measurements through the clamp body using various non-destructive testing (NDT) techniques and verification. This allowed the team to identify NDT techniques for rapid screening and accurately measure the amount of metal loss to determine clamp acceptability.

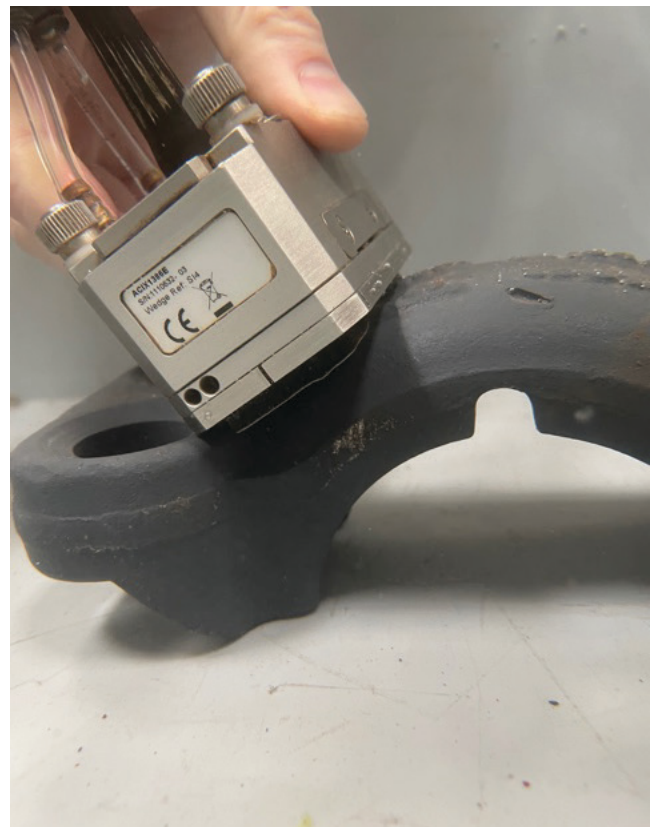
An appropriate inspection technique for bulk screening and detection of clamps with metal loss was identified, together with a more specialized technique for accurate quantification of metal loss in individual clamps. Appropriate, application-specific inspection procedures were developed for the selected inspection techniques.
