Oceaneering Inspects Oil Export Line Without Disrupting Traffic

Guided Wave Ultrasonic testing eliminated the need to disrupt transport of personnel offshore

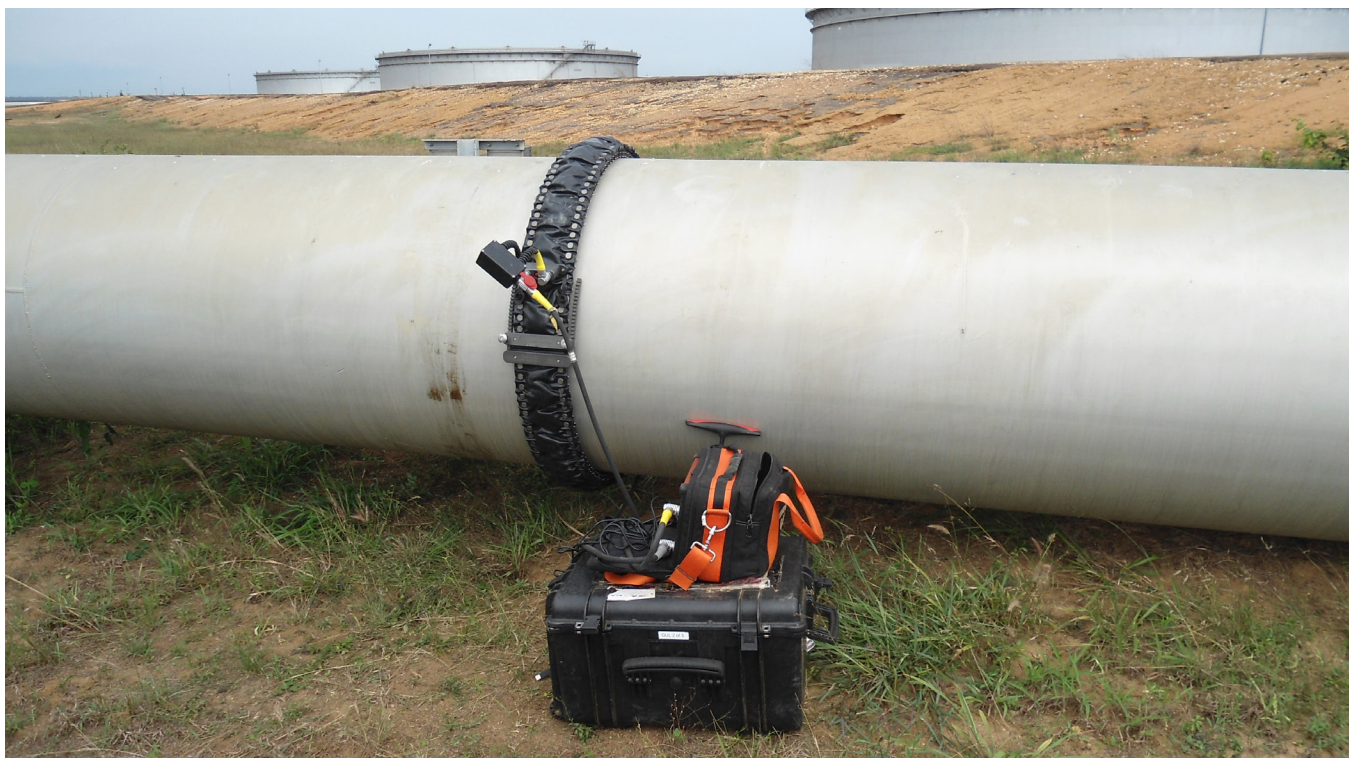
The GUL testing equipment and a qualified technician were already on site when Oceaneering received the client's inspection request. To conduct the inspection, a guided wave transducer ring was assembled with multiple pairs of transducers. The transducer ring was then placed around the pipe circumference approximately 10 ft from where the pipe entered the soil. The system generated ultrasonic waves along the length of the pipe to a distance of 20 ft underneath the road surface, successfully confirming the pipe's integrity.
