Oceaneering Completes Water Injection Pipeline Repair at Field Offshore Angola

Successful repair enables customer to resume operations and enhance production

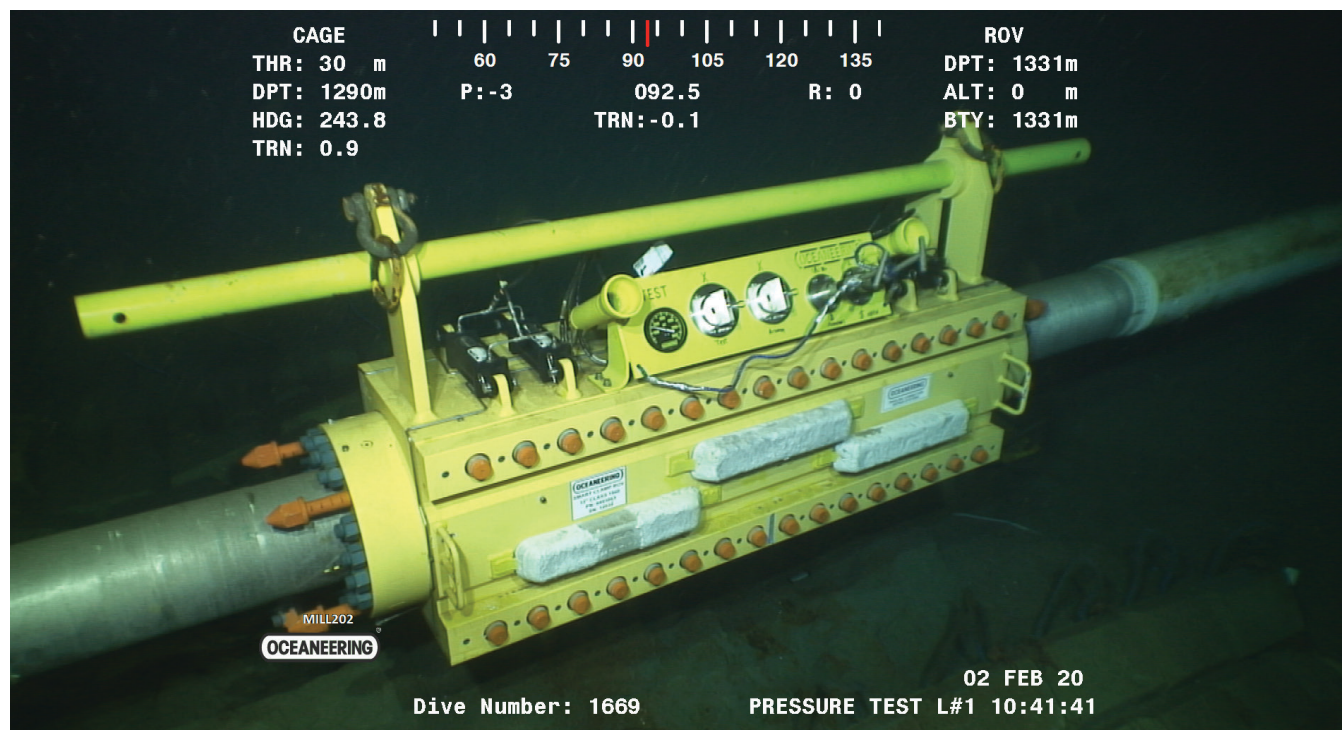
While offshore, the coating removal tool did encounter a few small hurdles, all of which the Oceaneering team was able to rectify while on the job.

The two Smart Clamps were successfully installed and passed subsequent pressure testing in February 2020. This enabled the client to bring the WI line back online at reduced pressure.
