# Oceaneering Offers One-Stop-Shop Reel Refurbishment in Angola

Local in-country Oceaneering team provides all necessary services and saves client approximately USD 3 million

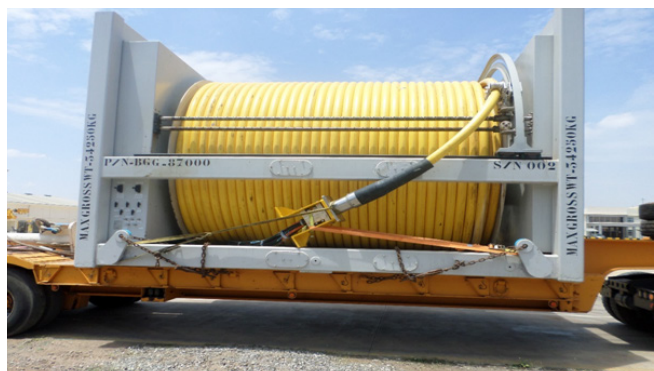
Oceaneering was also responsible for reinstalling and testing all controls as per piping and instrumentation schematics for the reeler. The drum was removed from the reeler and all bearings were serviced. Oceaneering also rebuilt and modified the subsea termination of the umbilical. The umbilical was an integrated electro-hydraulic design, and all testing of the umbilical was

done to original Factory Acceptance Testing (FAT) specifications. All assessments, repairs, and testing were conducted by Oceaneering personnel, except for termination of electrical cable which was conducted by a third party.
